PRELIMINARY RESULTS OF RECREATIONAL USE ATTAINABILITY ANALYSES OF THE DOUBLE MOUNTAIN FORK BRAZOS RIVER (1241) AND SABANA RIVER (1222C)

Dr. John Baker

Texas AgriLife Research|Extension

May 2, 2017

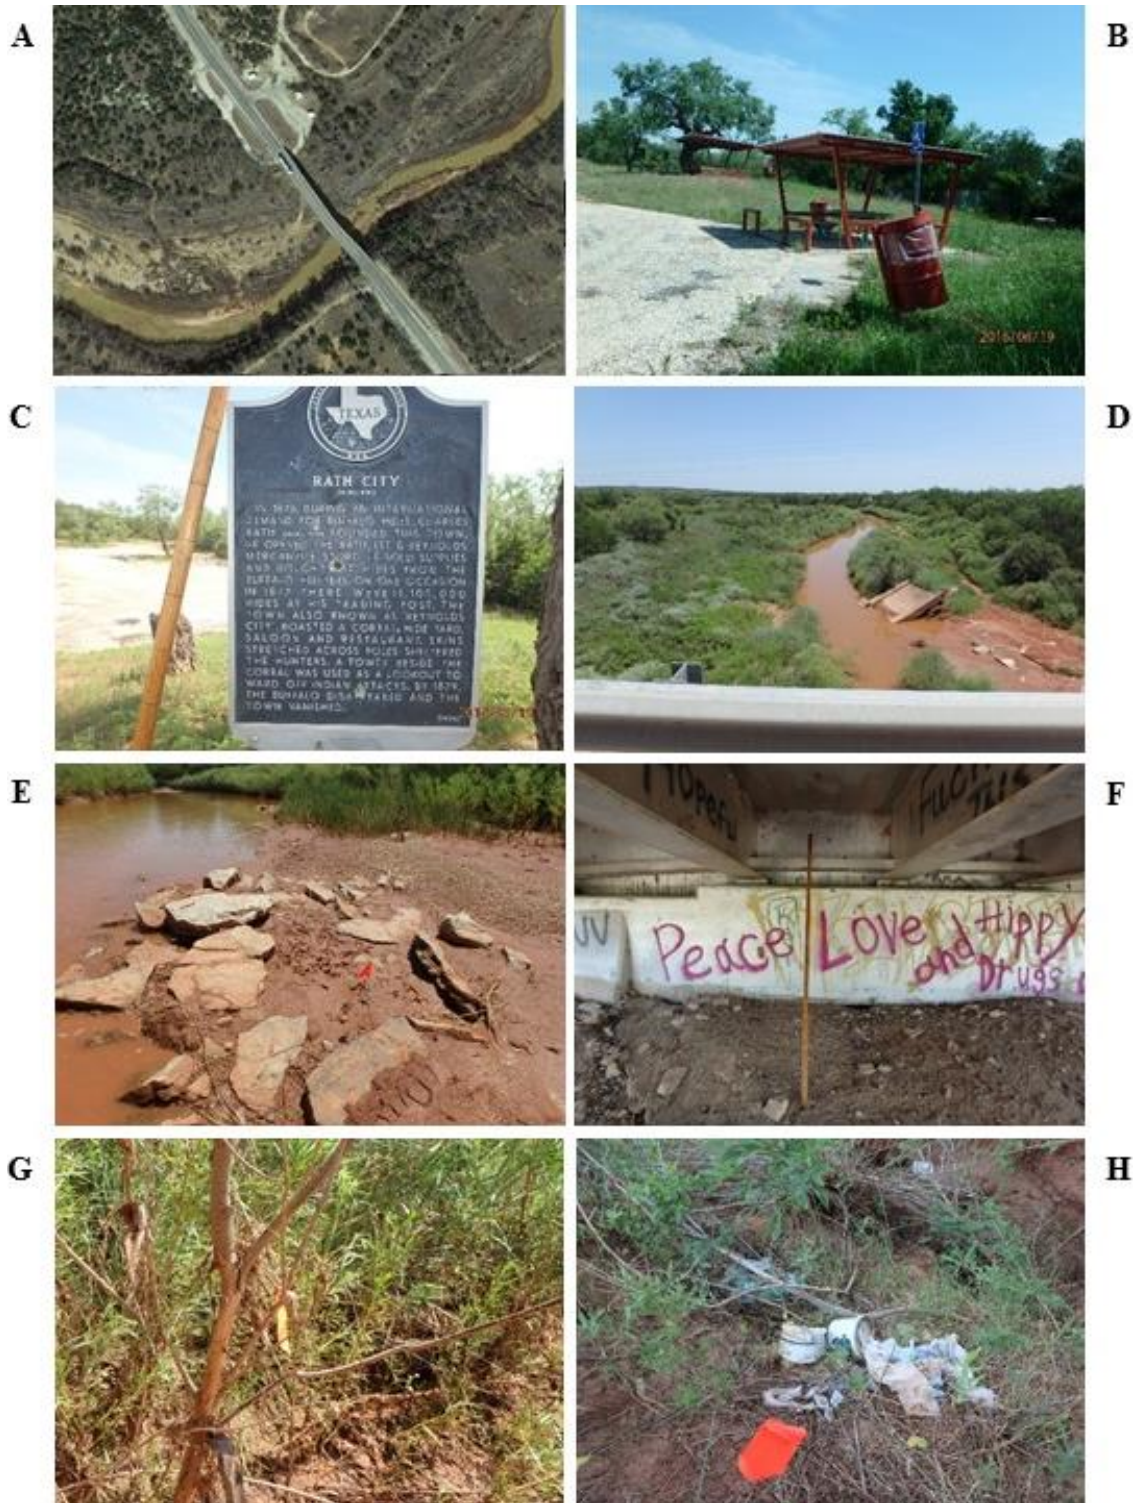
Figure 15. Photographs of an important area for primary contact recreation at the U.S. Highway 83 bridge crossing. A) An aerial photo of Smith Park and the bridge crossing. B) Two pavilions with picnic tables. C) A historical marker for Rath City. D) A downstream photo of the river. E) An old fire pit. F) Graffiti under the bridge. G) A dropline. H) Two empty bait containers.

The U.S. Highway 83 bridge crossing was also found to be an important area for primary contact recreation. This bridge crossing is a public park named Smith Park. It has two entrances (on opposite sides of U.S. 83) and 3 small pavilions each of which has a picnic table and garbage can. Smith Park has a historic marker for Rath City, which was a town founded in 1876. Rath City was established to meet the “international demand for buffalo hides” and had a trading post that, at one point in 1877, was in possession of 1,100,00 hides. In the middle of the channel of the Double Mountain Fork Brazos River adjacent to the U.S. 83 bridge there is a large concrete slab, probably the remnants of a bridge, that may serve as a platform for primary contact recreational activities. One interviewee, who is a prominent community leader in Stonewall County, said he saw 200 people swimming in the river at this location last year. He said, in an average year, about 50 people swim here. The interviewee in interview 21, who has been familiar with the river for 50 years, said he used to swim here 40 days per year in the 1970s and 80s.

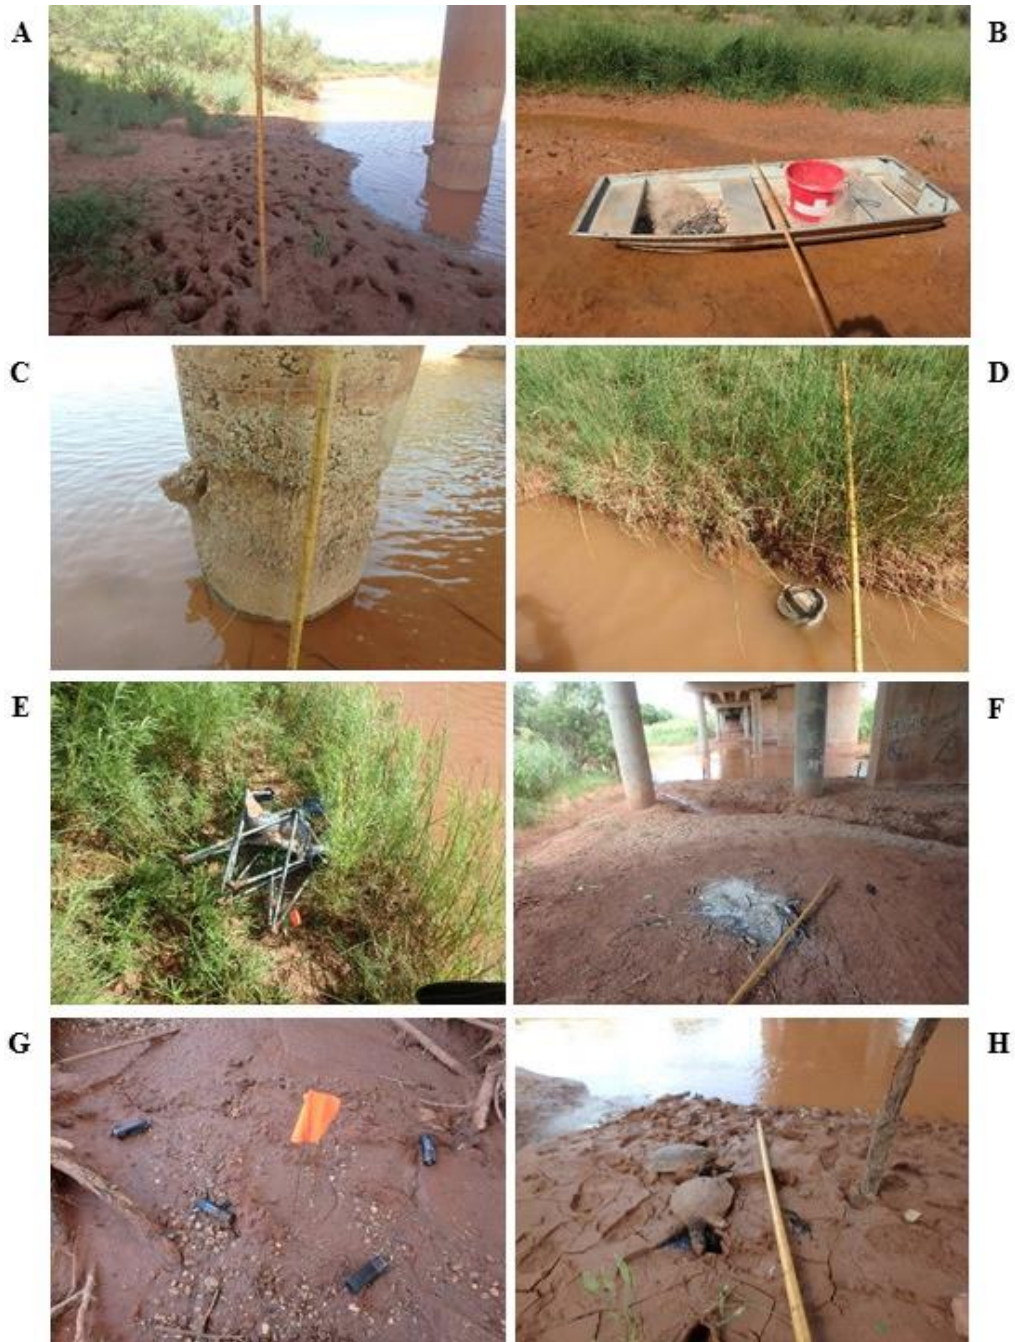
Figure 16. Photographs of indications of human use found on the Double Mountain Fork Brazos River. A) Multiple footprints next to the water. B) A boat filled with 2 cast nets and a dip net. C) A drop line. D) A fishing bait bucket. E) A chair on the bank. F) Evidence of a camp fire. G) Shotgun shells. H) Dead hunted aquatic turtles.

No primary contact recreation activities were observed on the Double Mountain Fork Brazos River during the field surveys conducted in this RUAA project. A secondary contact recreation activity was observed where one person was found on the shore with their feet touching the water at survey site 1241.82. Indications of human use (IHUs) found related to secondary contact include fishing tackle (9 survey sites, Figures 16B-D) and boating (2 survey sites, Figure 16B). Twenty-three IHUs related to non-contact activities were found, including: an ATV trail, beverage cans and bottles, bullet casings, burnt wood (Figure 16F), children's footwear, clothing, decorative lights on bank, a deer feeder, a fire pit, a fishing platform, a folding chair (Figure 16E), foot paths/prints (Figure 16A), graffiti, hunted turtles (Figure 16H), hunting blinds, an old lawn chair, roads, shooting targets, shotgun shells (Figure 16G), a tent tie down, tire ruts and a trail camera (Table 4). Footpaths indicate recreational use at several survey sites. For instance, at survey site 1241.65, a path with signs of use leads from Smith Park to the stream. At site 1241.77, technicians found barefoot prints of an adult and child on the bank less than 1 meter from the water's edge. At site 1241.12, there were sandals near the river and footprints along the river banks. Survey sites under bridges also showed various indications of human use. For

instance, at site 1241.76, a trot line was found attached to the bridge. There is also a road at the southeast corner of the bridge leading to stream. Under the bridge and in the immediate area there were numerous footprints, some quite small that seemed to belong to children. At survey site 1241.73, fishing line with a weight, a bobber and a minnow bucket were all found near the FM 1835 bridge. At survey site 1241.82, indications of human use included a fishing bobber, foot prints, a pistol shell casing and shotgun shells; in addition, multiple roads lead under the bridge. The survey site 1241.42 showed multiple indications of human use, mostly around the S.H. 70 bridge.

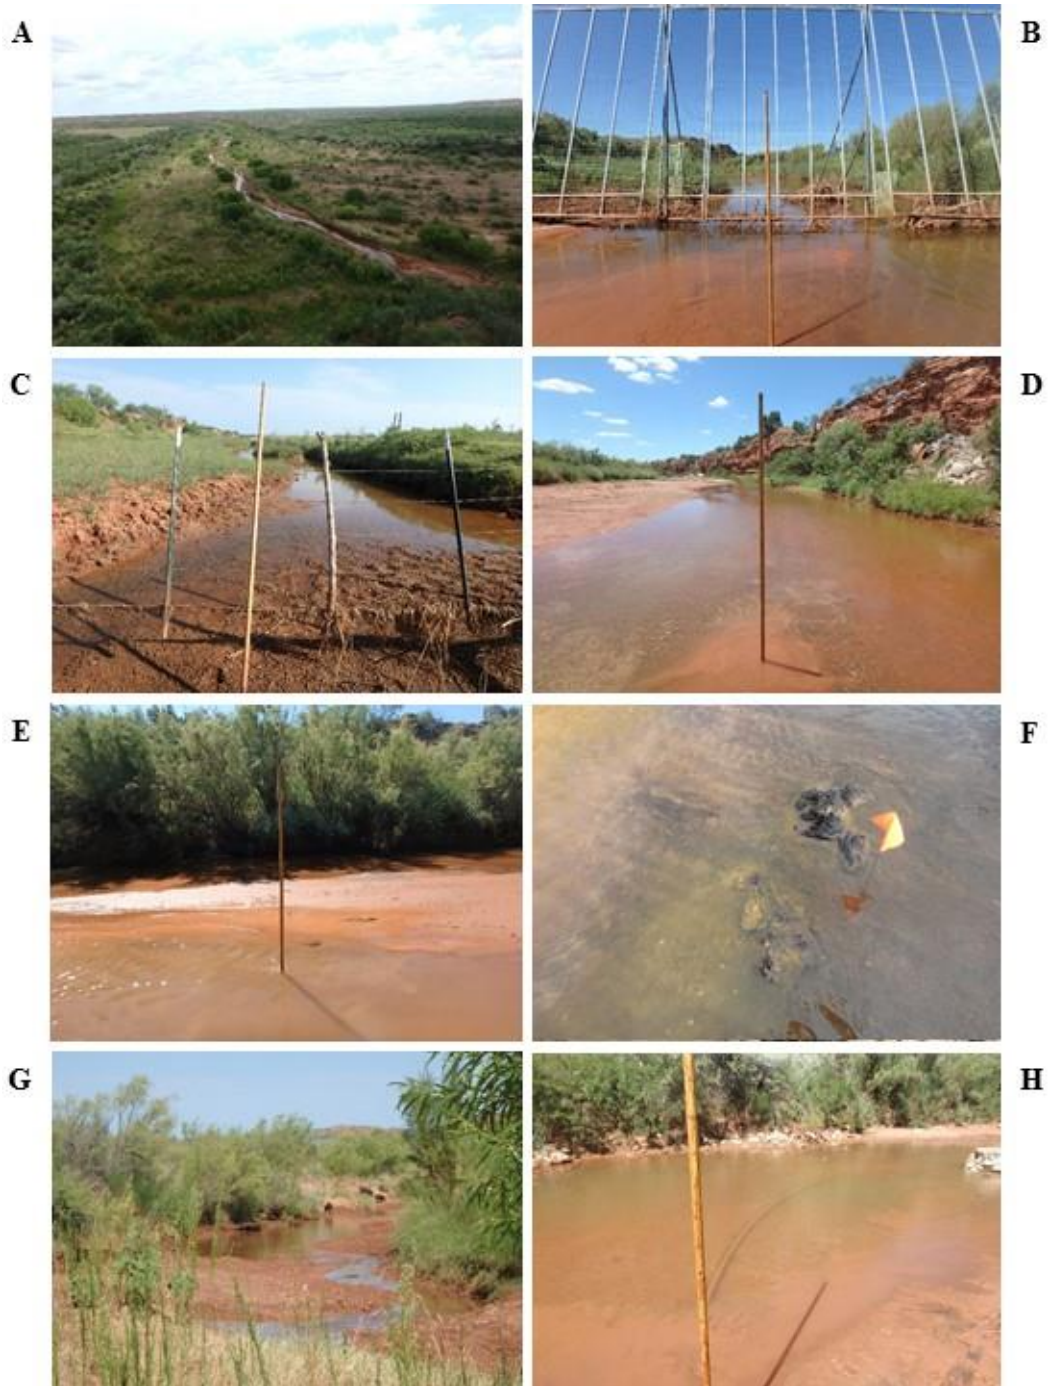
Figure 18. Factors that impede recreation on the Double Mountain Fork Brazos River. A) Parts of the river are remote and difficult to access. B-C) Fences crossing the stream reducing accessibility. D) Steep banks. E) Thick vegetation on the banks. F) Cow manure in the stream. G) Feral pigs in the stream. H) An industrial pipeline crossing the stream.

Two hundred and eighteen surrounding conditions that impede recreation were recorded during surveys on the river (Table 6). Private property (61) was recorded as the most frequent surrounding condition that impedes access followed by no public access (58), no roads (4, Figure 18A) and fences (3, Figures 18B and 18C). Other surrounding conditions that impede access were dangerous wildlife, including feral hogs (Figures 18G, 19F and 19G), snakes, coyotes, and bob cats (41), steep banks (1), garbage (6) and industrial structures related to oil extraction (2). At one survey site (1241.63), petroleum extraction activities were located within 100 meters of the river and in another site (1241.67) multiple pipes crossed the river segment.

During field surveys, technicians reported signs of cattle using the river at many survey sites (28, Figures 18F, 19C, 19D and 19E). Other conditions that impede recreation related to water quality were stagnant water (6, Figure 19H), poor water quality (6) and shallow water (2).

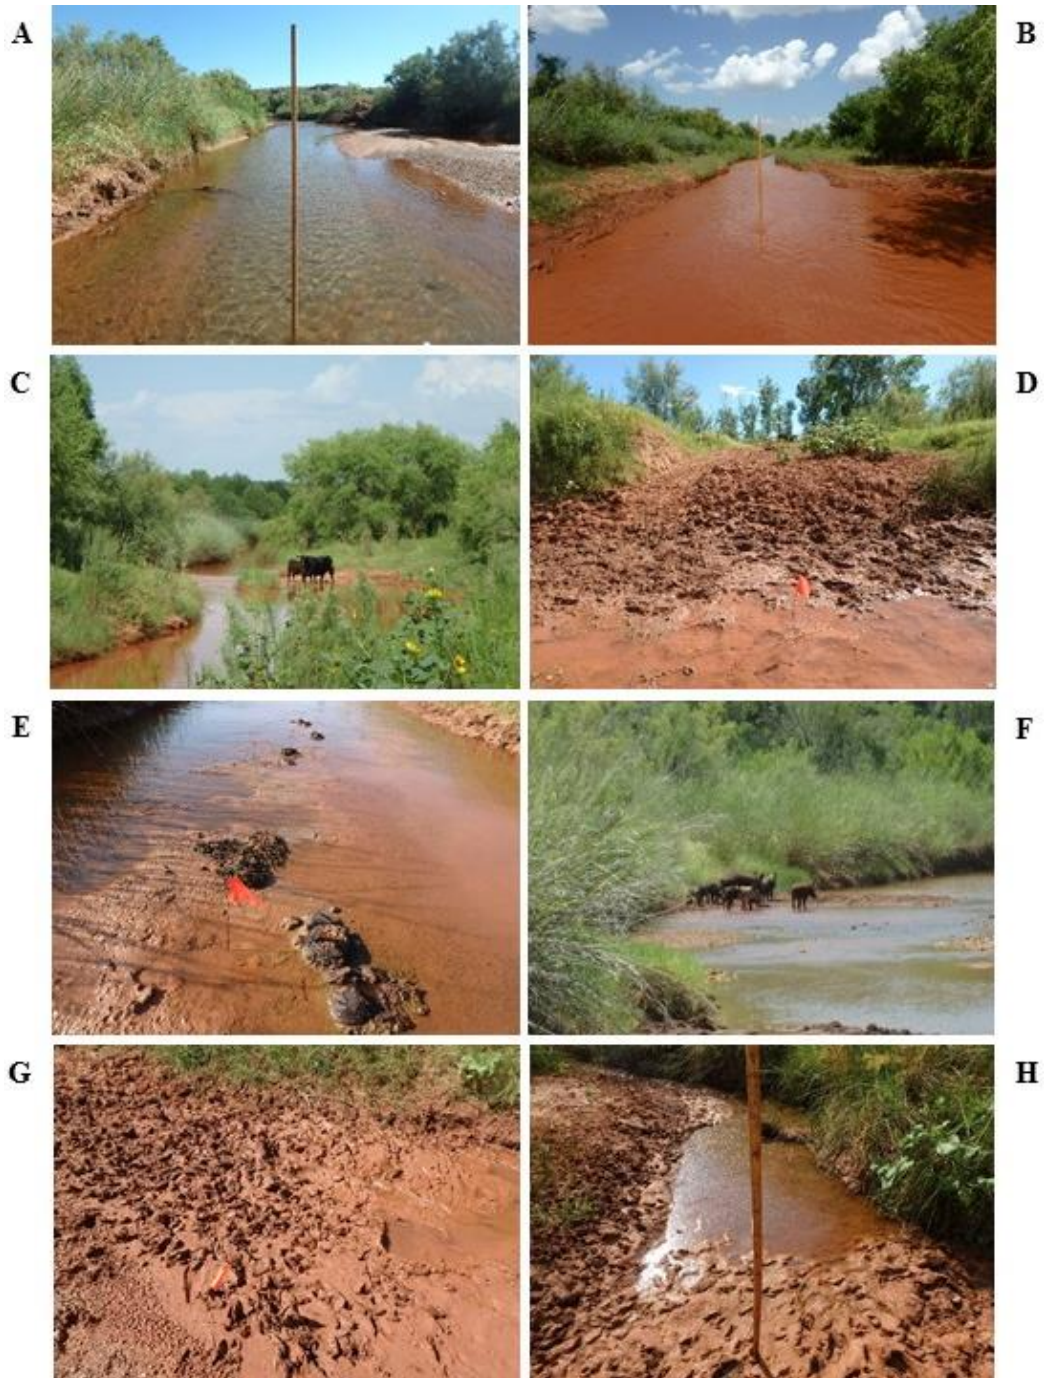
Figure 19. Photographs relating to water quality on the Double Mountain Fork Brazos River. A) A stretch of the stream with clear water. B) Clay colored stream water. C) Two cows in the stream. D) Footprints of cattle accessing the stream. E) Cow manure in the stream. F) Six feral pigs in the stream. G) Feral pig tracks next to the stream. H) A small isolated pool with a film on the water's surface.

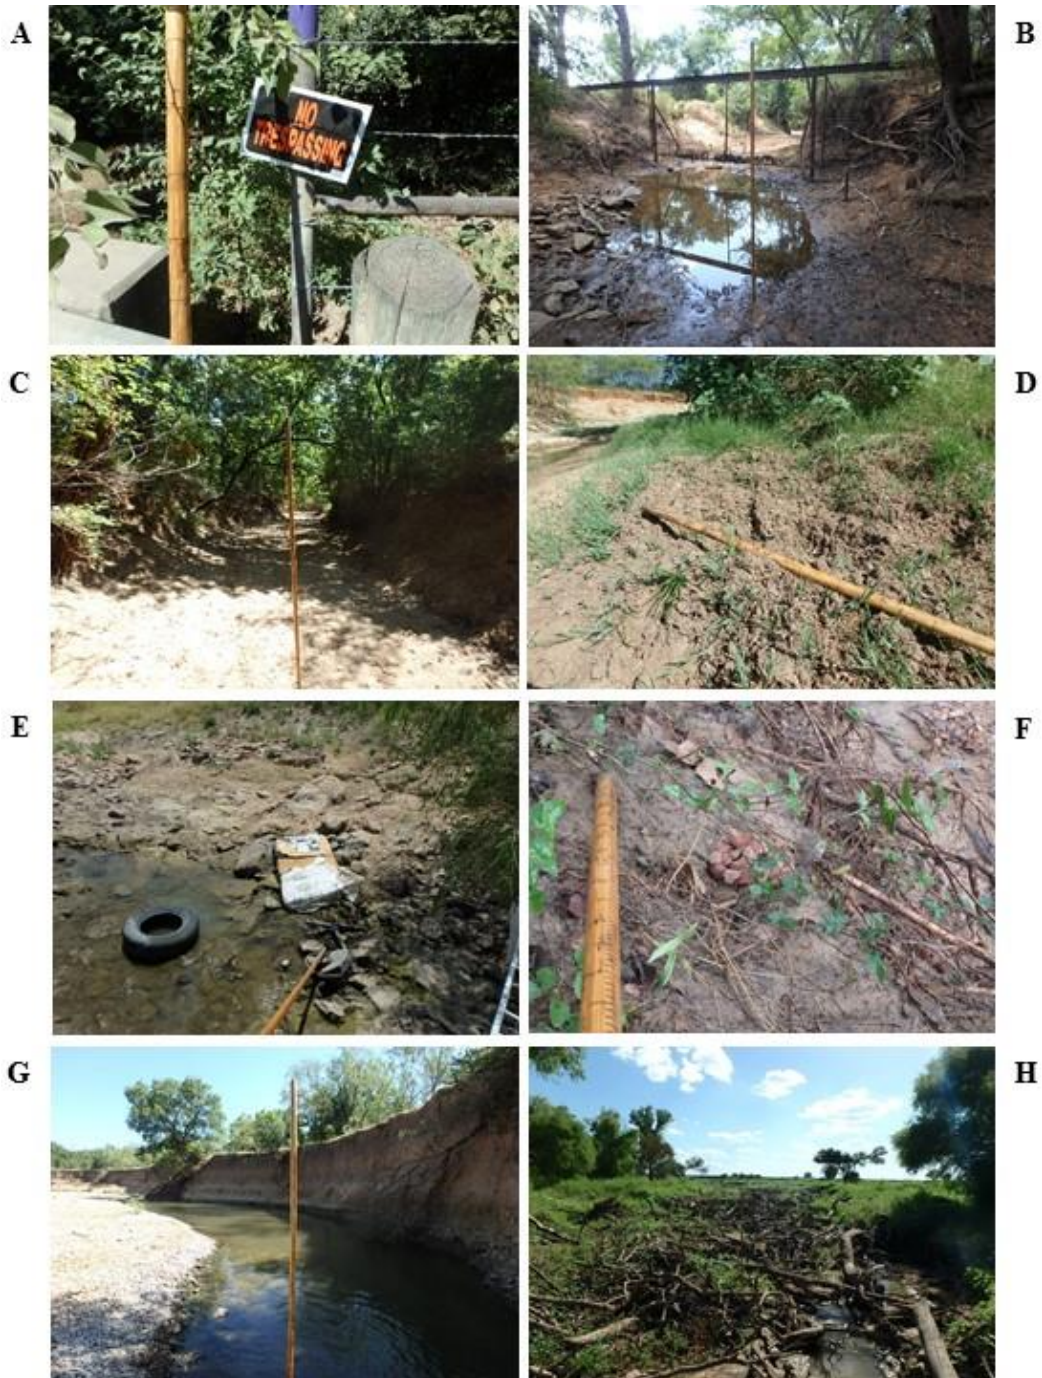
Figure 31. Factors that impede recreation on the Sabana River. A) A no trespassing sign. B) A fence crossing the stream reducing accessibility. C) No water in parts of the stream. D) Evidence of rooting by feral pigs. E) Garbage in the water. F) Dangerous wildlife (A copperhead snake). G) A steep bank preventing access to one side of the stream. H) A log jam that is reducing accessibility.

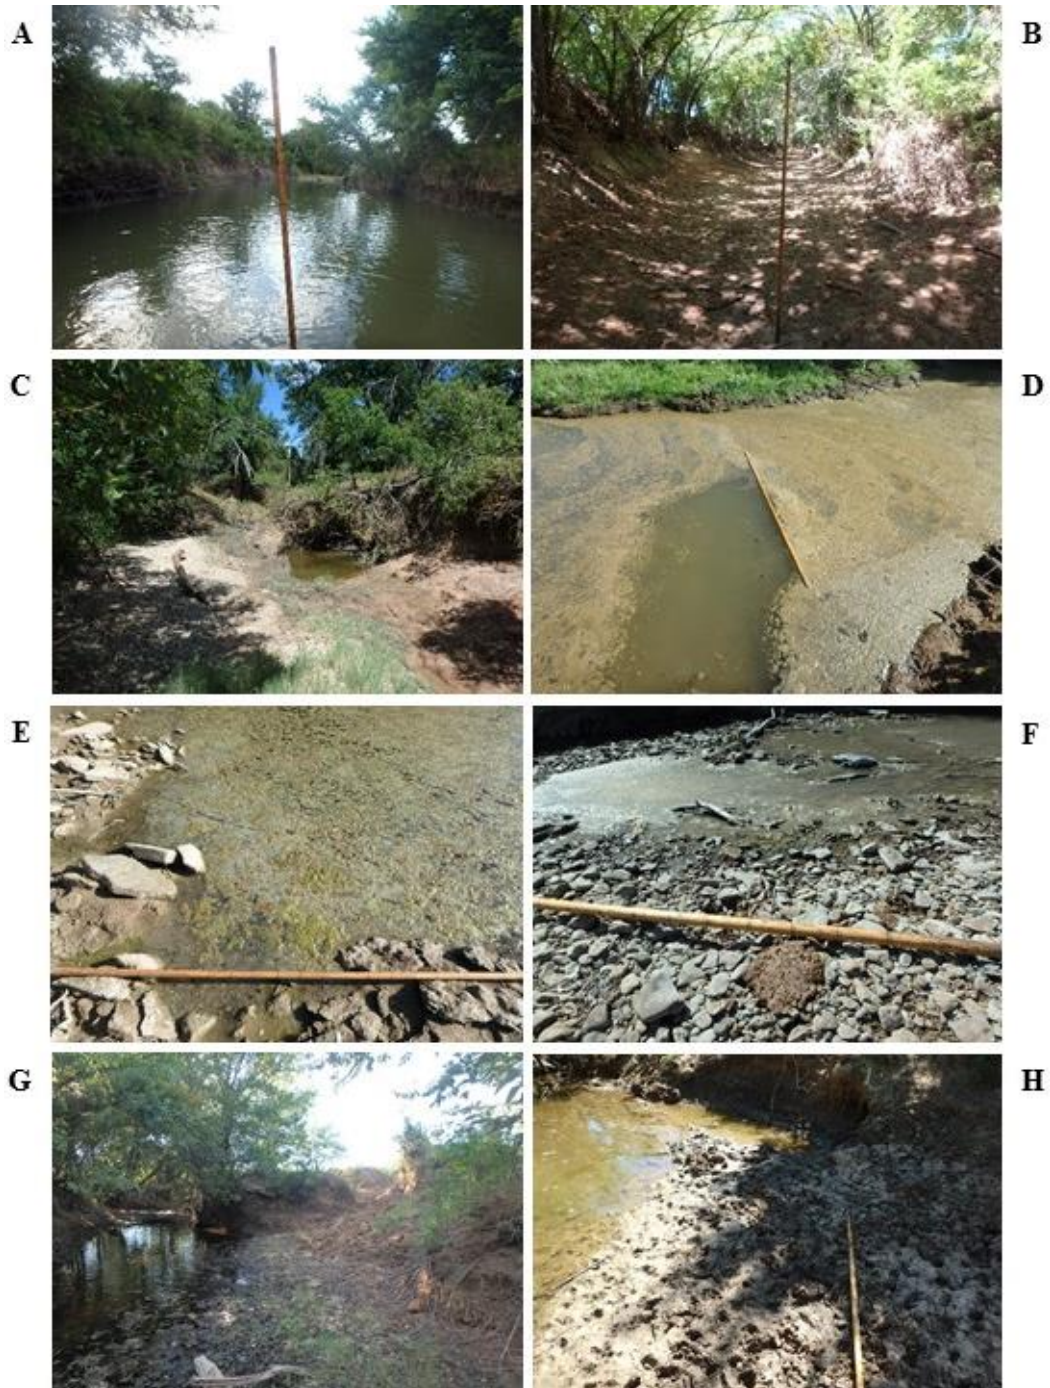
Figure 32. Photographs relating to water quality on the Sabana River. A) A photo of the stream that characterizes some parts of the Sabana River. B) A dry stream bed at survey site 1222C.7. C) A small isolated pool with green water. D-E) Green algae growing on the surface of the water at survey sites 1222C.44 and 1222C.21, respectively. F) Cow manure next to the stream. G) A cow trail leading down to the stream. H) An area next to the stream with a large number of animal tracks.

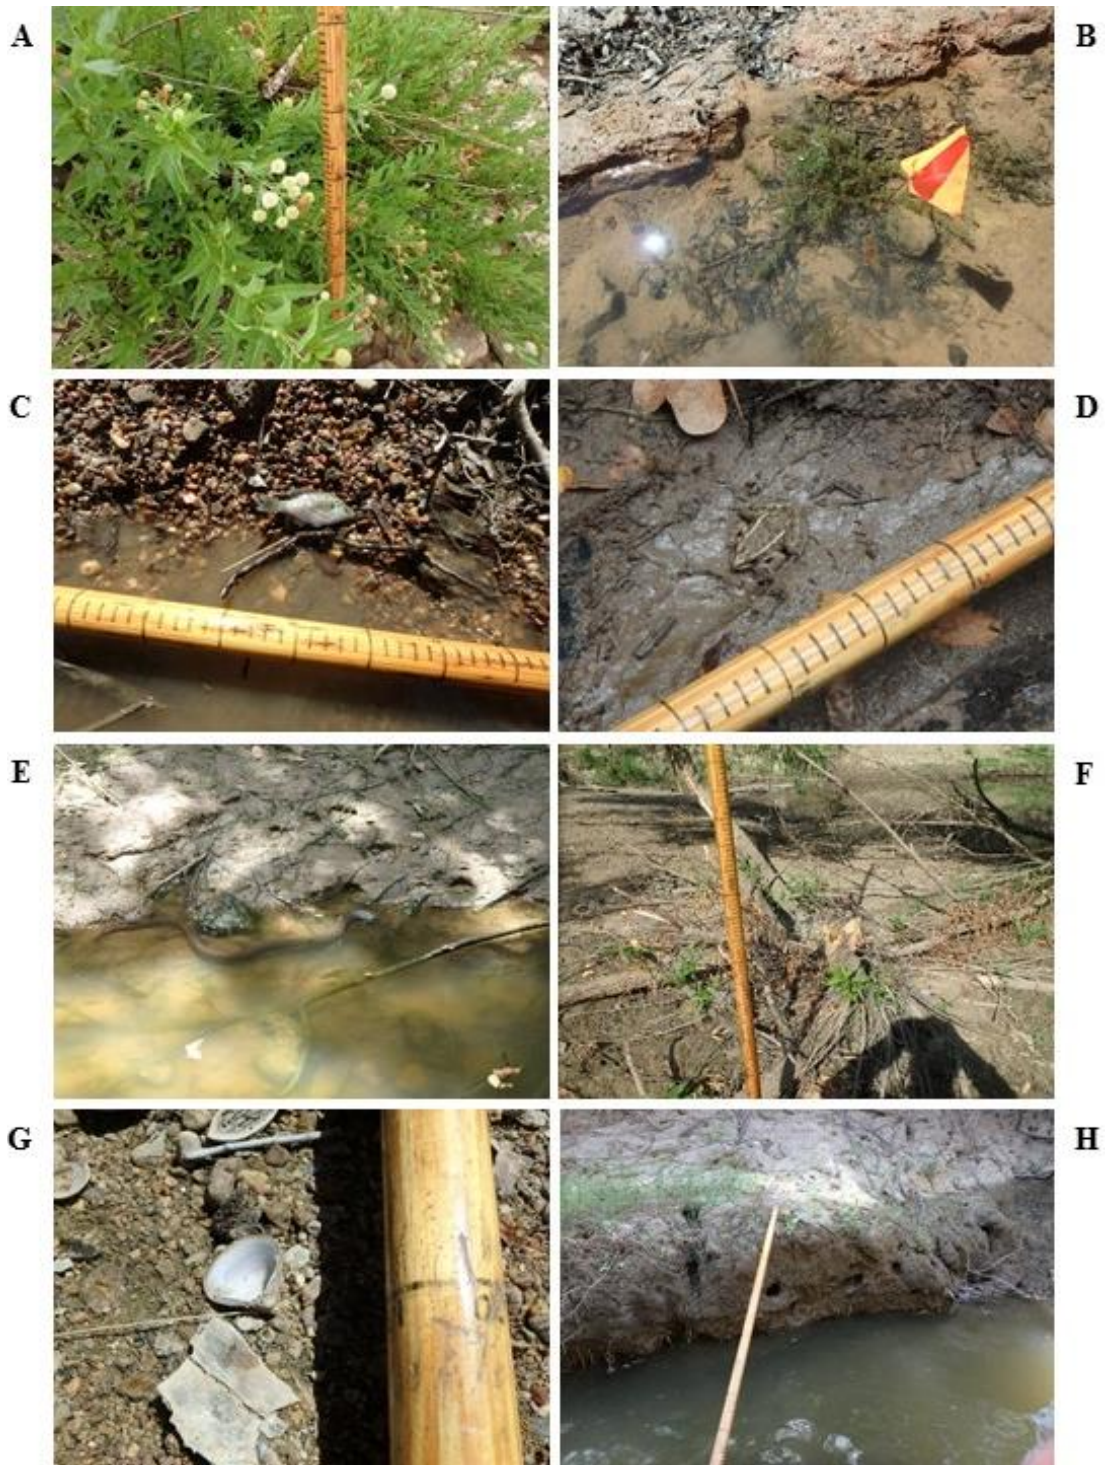
Figure 33. Photographs of sustained aquatic habitat recorded during field surveys on the Sabana River. A) Wetland vegetation (*Cephalanthus occidentalis*) on the stream bank. B) Aquatic vegetation in the stream. C) A fish. D) A frog next to the water. E) A water snake in the stream. F) Evidence of beavers. G) A mussel shell. H) Crawfish burrows.
